**Flood Control Project Maintenance  
Levee Inspections**  
**LMA District Cover Sheet**  
**Spring 2018 Levee Inspection Results**

**Levee District No. 0003 (Glenn County)**

**Levee Inspection Report By Mile - Spring 2018**

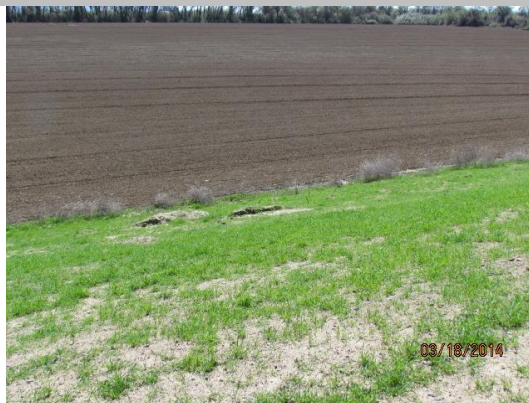
Photo 1 of 1 : SP\_2018\_LD0003\_27\_55\_20180305\_00036.jpg

LM Start	0.69	Rating **	M	Issue No.	55
LM End	0.69	Issue Type +	Ma	Location *	WS
Category	Earthen Levee			GPS Latitude/Longitude	
				Start	End
Item	Animal Control			39.388716 °	39.388716 °
				-121.997774 °	-121.997774 °
DWR ID	DWR_LD0003_01_s _ 2014_55				
Comment Code					
A1 : Exterminate rodents and backfill and compact or grout burrows.					
Inspector Comment

View of the rodent activity along the waterside slope.

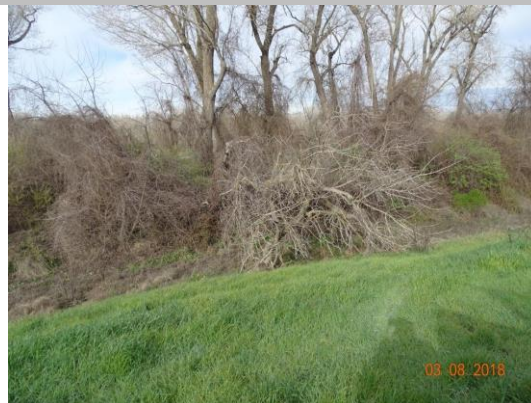
Photo 1 of 1 : SP\_2018\_LD0003\_27\_43\_20180312\_00108.jpg

LM Start	1.34	Rating **	M	Issue No.	43
LM End	1.34	Issue Type +	Ma	Location *	WS
Category	Earthen Levee			GPS Latitude/Longitude	
				Start	End
Item	Encroachments			39.395903 °	39.395903 °
				-122.001490 °	-122.001490 °
DWR ID	DWR_LD0003_01_s_2018_43				
Comment Code					
TR : Tree or limb					
Inspector Comment					
Remove the tree from the slope and toe.

View of the tree down on the slope and toe.

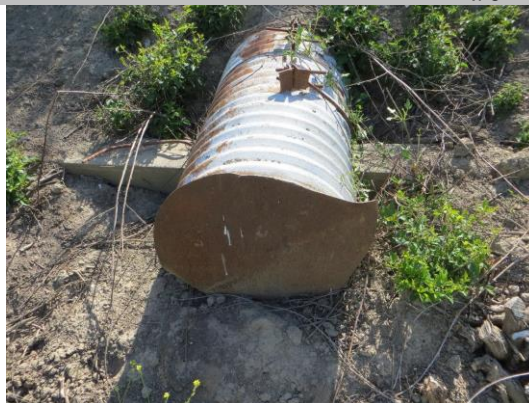
Photo 2 of 3 : UCIP\_SP\_2018\_14573\_24037.jpg

LM Start	1.47	Rating **	M	Issue No.	106 (cont)	
LM End	1.47	Issue Type +	En	Location *		
Category	Supplemental			GPS Latitude/Longitude		
				Start		End
Item	DWR UCIP Field Study			39.397780 °	39.397780 °	
				-122.002074 °	-122.002074 °	
DWR ID						
Comment Code						
Inspector Comment						
FS_ID:14573 DS_ID:18830 EP_NO: 9930 Repair Type: Non-Urgent Crossing Status: Found UCIP Comments: Steel plate welded over WS end of pipe. Slide gate at WS toe missing. Appears abandoned. FIELD_STRUCT_DESC: 24-inch corrugated metal irrigation pipe through the levee, 14.5 feet below the crown. Slide gate on waterside (WS) end. 7-foot by 9-foot concrete diversion box at landward toe (Automatic Board Order (ABO) issued as Permit No. 9930, 1974 - Steel Ranch). [Additional Reference(s): DWR Levee Log, 1992. USACE Sacramento O&M Manual 136, March 1960 (HLM 21.89)]. FS Date: 6/4/2013

Steel plate welded over end of pipe on WS toe.

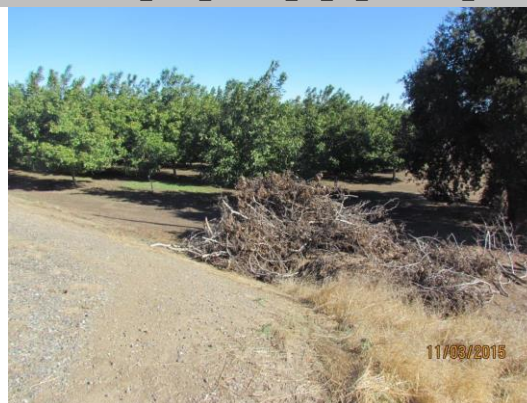
Photo 1 of 1 : SP\_2018\_LD0003\_27\_66\_20180305\_00045.jpg

LM Start	4.33	Rating **	M	Issue No.	66
LM End	4.33	Issue Type +	En	Location *	LS
Category	Earthen Levee			GPS Latitude/Longitude	
				Start	End
Item	Encroachments			39.430927 °	39.430927 °
				-121.987142 °	-121.987142 °
DWR ID	DWR_LD0003_01_f_2015_66				
Comment Code					
PR : Prunings					
Inspector Comment					
Remove the prunings from the landside slope.

View of the prunings along the landside toe.

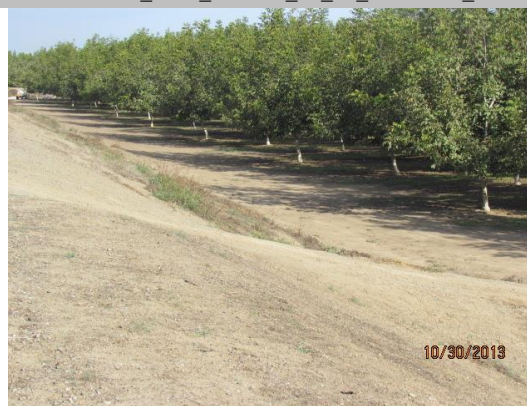
Photo 1 of 1 : SP\_2018\_LD0003\_27\_64\_20180305\_00043.jpg

LM Start	4.63	Rating **	U	Issue No.	64
LM End	4.68	Issue Type +	Ma	Location *	LS
Category	Earthen Levee			GPS Latitude/Longitude	
				Start	End
Item	Animal Control			39.435205 °	39.435855 °
				-121.988097 °	-121.988252 °
DWR ID	DWR_LD0003_01_f_2013_64				
Comment Code					
A3 : No rodents visible, but rodent burrows visible; need to backfill and compact or grout burrows.					
Inspector Comment

View of the rodent activity along the landside slope.

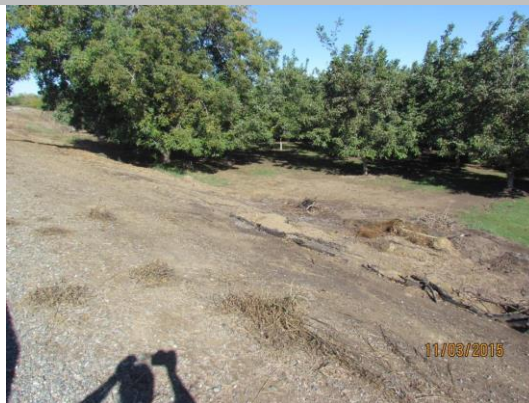
Photo 1 of 1 : SP\_2018\_LD0003\_27\_21\_20180305\_00014.jpg

LM Start	5.06	Rating **	U	Issue No.	21
LM End	5.25	Issue Type +	Ma	Location *	LS
Category	Earthen Levee			GPS Latitude/Longitude	
				Start	End
Item	Animal Control			39.441128 °	39.443793 °
				-121.990475 °	-121.991297 °
DWR ID	DWR_LD0003_01_f_2015_21				
Comment Code					
A3 : No rodents visible, but rodent burrows visible; need to backfill and compact or grout burrows.					
Inspector Comment

View of the rodent holes along the landside slope.

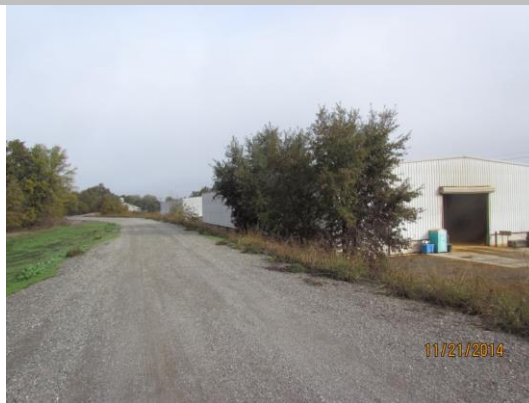
Photo 1 of 1 : SP\_2018\_LD0003\_27\_7\_20180305\_00005.jpg

LM Start	6.24	Rating **	M	Issue No.	7
LM End	6.38	Issue Type +	Ma	Location *	LS
Category	Earthen Levee			GPS Latitude/Longitude	
				Start	End
Item	Trim / Thin Trees			39.457968 °	39.459955 °
				-121.993712 °	-121.993512 °
DWR ID	DWR_LD0003_01_s_2012_7				
Comment Code					
T1 : Trim trees to at least five feet above ground level.					
Inspector Comment

Trim the trees 5 feet for better visibility.

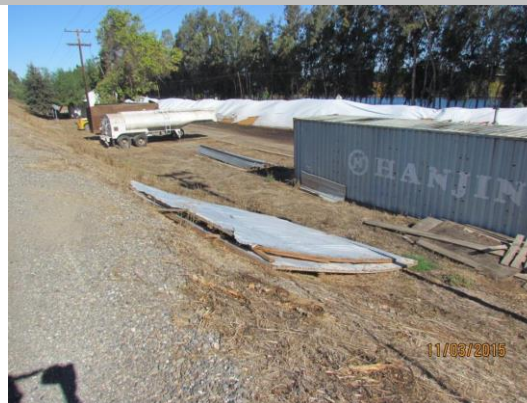
Photo 1 of 1 : SP\_2018\_LD0003\_27\_74\_20180305\_00052.jpg

LM Start	6.43	Rating **	U	Issue No.	74
LM End	6.43	Issue Type +	En	Location *	LS
Category	Earthen Levee			GPS Latitude/Longitude	
				Start	End
Item	Encroachments			39.460563 °	39.460563 °
				-121.993195 °	-121.993195 °
DWR ID	DWR_LD0003_01_f_2015_74				
Comment Code					
DE : Debris					
Inspector Comment					
Remove the metal roof from the landside slope.

View of the metal roof laying on the landside slope.

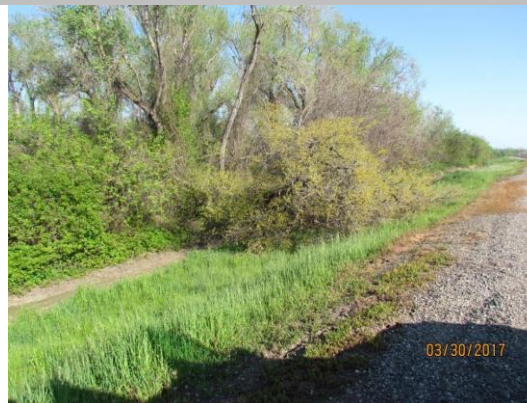
Photo 1 of 1 : SP\_2018\_LD0003\_27\_47\_20180305\_00024.jpg

LM Start	6.91	Rating **	M	Issue No.	47
LM End	6.91	Issue Type +	Ma	Location *	WS
Category	Earthen Levee			GPS Latitude/Longitude	
				Start	End
Item	Encroachments			39.467358 °	39.467358 °
				-121.991333 °	-121.991333 °
DWR ID	DWR_LD0003_01_s_2017_47				
Comment Code					
TR : Tree or limb					
Inspector Comment					
Remove the tree from the waterside slope and toe.

View of the tree on the waterside slope and toe.

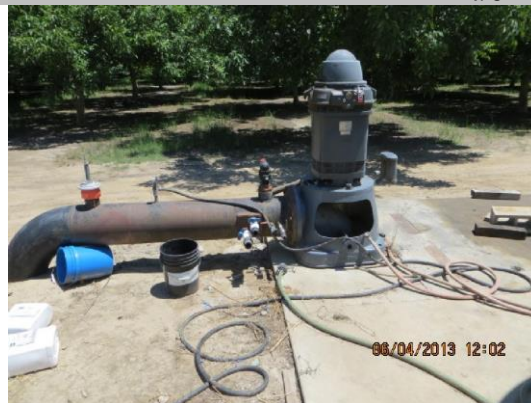
Photo 1 of 2 : UCIP\_SP\_2018\_14686\_24184.jpg

Pump located on LS toe next to concrete distribution box.

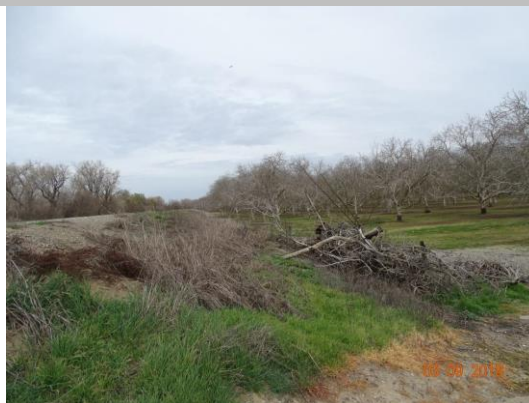
Photo 1 of 1 : SP\_2018\_LD0003\_27\_67\_20180312\_00110.jpg

LM Start	7.21	Rating **	M	Issue No.	67
LM End	7.21	Issue Type +	En	Location *	LS
Category	Earthen Levee			GPS Latitude/Longitude	
				Start	End
Item	Encroachments			39.471695 °	39.471695 °
				-121.991038 °	-121.991038 °
DWR ID	DWR_LD0003_01_s_2018_67				
Comment Code					
PR : Prunings					
Inspector Comment					
Remove the prunings from the landside slope.

View of the prunings on the landside slope.

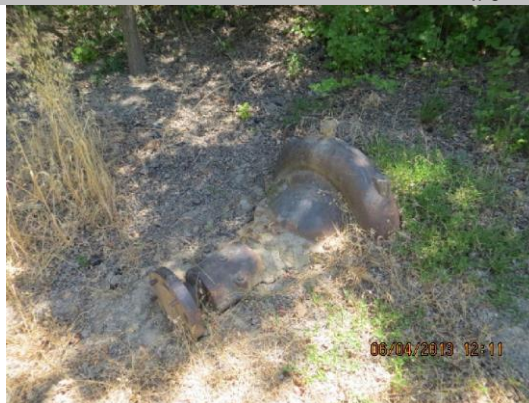
Photo 2 of 3 : UCIP\_SP\_2018\_14687\_24186.jpg

Pump visible off WS toe, next to pond.

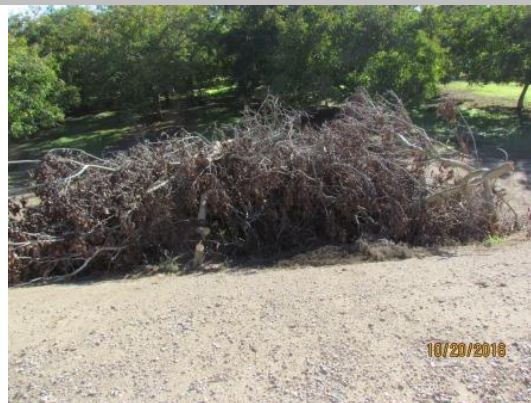
Photo 1 of 1 : SP\_2018\_LD0003\_27\_60\_20180305\_00039.jpg

LM Start	7.68	Rating **	M	Issue No.	60
LM End	7.68	Issue Type +	En	Location *	LS
Category	Earthen Levee			GPS Latitude/Longitude	
				Start	End
Item	Encroachments			39.478464 °	39.478464 °
				-121.990686 °	-121.990686 °
DWR ID	DWR_LD0003_01_f_2013_60				
Comment Code					
PR : Prunings					
Inspector Comment					
Remove the prunings from the landside toe.

View of the prunings along the landside toe.

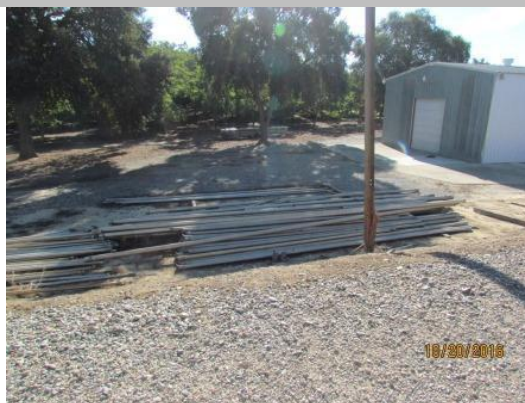
Photo 1 of 1 : SP\_2018\_LD0003\_27\_94\_20180305\_00060.jpg

LM Start	9.18	Rating **	U	Issue No.	94
LM End	9.18	Issue Type +	En	Location *	LS
Category	Earthen Levee			GPS Latitude/Longitude	
				Start	End
Item	Encroachments			39.498253 °	39.498253 °
				-121.987103 °	-121.987103 °
DWR ID	DWR_LD0003_01_f_2016_94				
Comment Code					
EQ : Equipment					
Inspector Comment

View of the ag pipes along the landside toe.

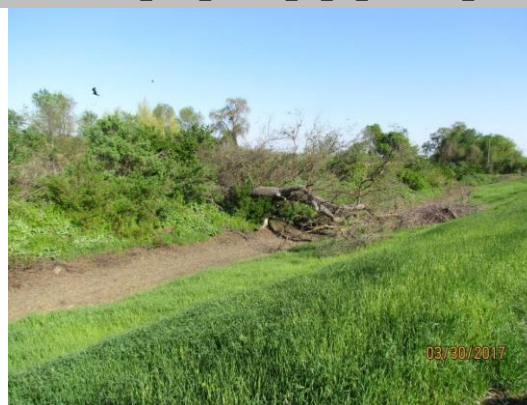
Photo 1 of 1 : SP\_2018\_LD0003\_27\_49\_20180305\_00026.jpg

LM Start	9.29	Rating **	M	Issue No.	49
LM End	9.29	Issue Type +	Ma	Location *	WS
Category	Earthen Levee			GPS Latitude/Longitude	
				Start	End
Item	Encroachments			39.499720 °	39.499720 °
				-121.986497 °	-121.986497 °
DWR ID	DWR_LD0003_01_s_2017_49				
Comment Code					
TR : Tree or limb					
Inspector Comment					
Remove the tree from the waterside slope and toe.

View of the tree along the waterside slope and toe.

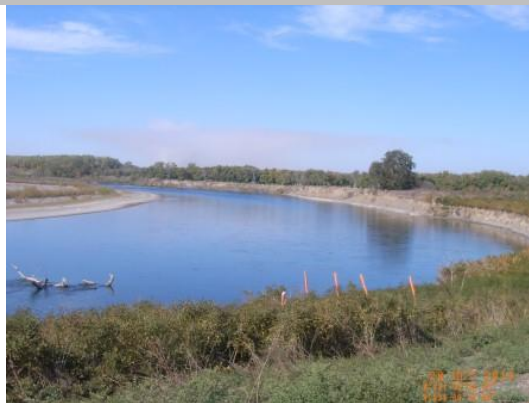
Photo 2 of 3 : SP\_2018\_LD0003\_27\_10\_20180305\_00008.jpg

USACE 2013 Photo #2

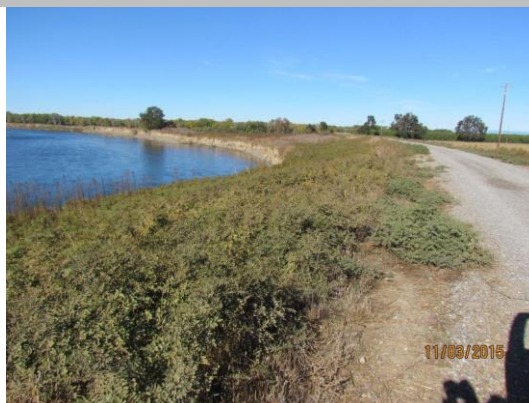
Photo 2 of 6 : SP\_2018\_LD0003\_27\_50\_20180305\_00028.jpg

View of the erosion along the waterside toe. Same site as the USACE erosion issue.

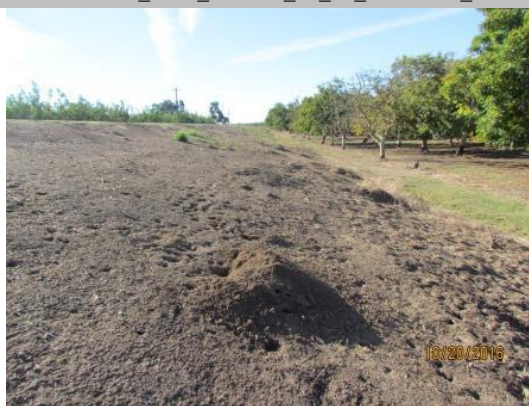
Photo 1 of 1 : SP\_2018\_LD0003\_27\_93\_20180305\_00059.jpg

LM Start	9.94	Rating **	M	Issue No.	93
LM End	10.03	Issue Type +	Ma	Location *	WS
Category	Earthen Levee			GPS Latitude/Longitude	
				Start	End
Item	Animal Control			39.508912 °	39.510199 °
				-121.983989 °	-121.983912 °
DWR ID	DWR_LD0003_01_f_2016_93				
Comment Code					
A1 : Exterminate rodents and backfill and compact or grout burrows.					
Inspector Comment

View of the rodent holes along the waterside slope.

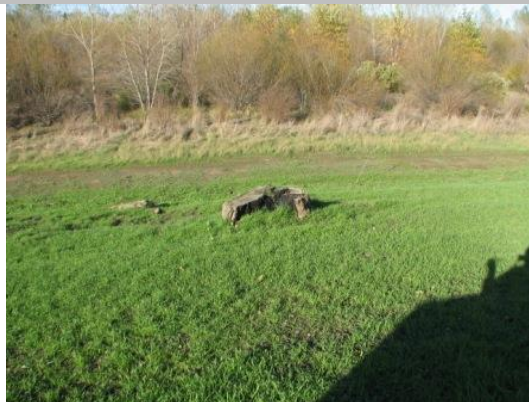
Photo 1 of 1 : SP\_2018\_LD0003\_27\_30\_20180305\_00017.jpg

LM Start	10.67	Rating **	N	Issue No.	30
LM End	10.67	Issue Type +	Ma	Location *	WS
Category	Earthen Levee			GPS Latitude/Longitude	
				Start	End
Item	Trim / Thin Trees			39.517715 °	39.517715 °
				-121.979155 °	-121.979155 °
DWR ID	DWR_LD0003_01_f_2016_30				
Comment Code					
T5 : Tree stumps.					
Inspector Comment

View of the stump along the slope.
